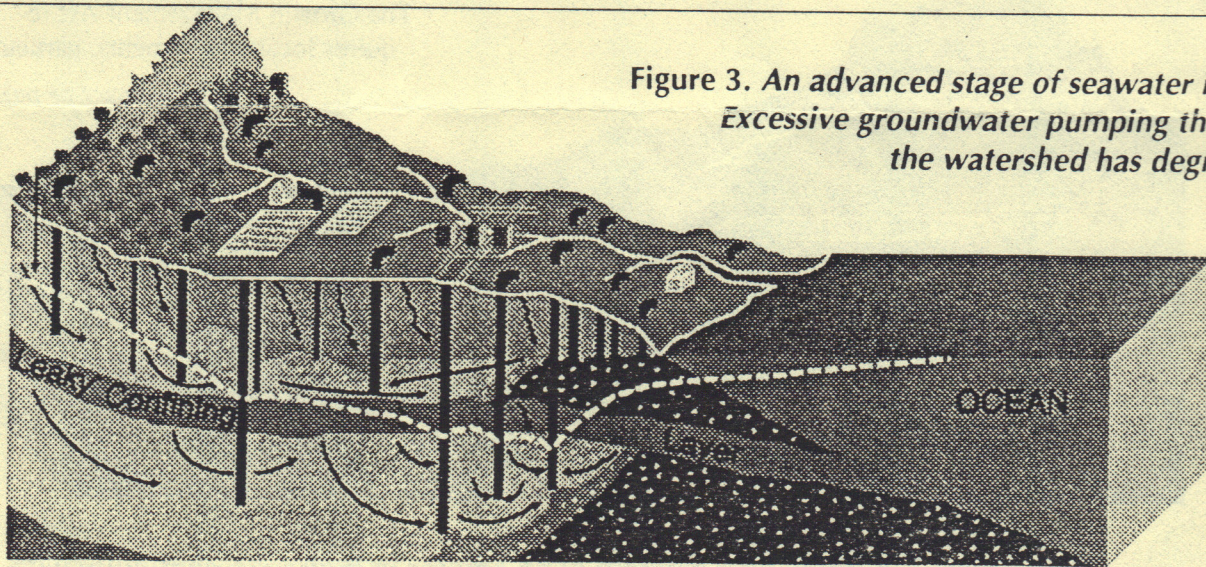
Figure 3. An advanced stage of seawater intrusion.  
Excessive groundwater pumping throughout  
the watershed has degraded the  
aquifer.
